# Manhole Inspection Summary

Manhole # S55C\_\_012MH

**Inspection** ☐ Is Incomplete Rating: **4) Poor**

**Location** Address: **3800 e baltimore st**

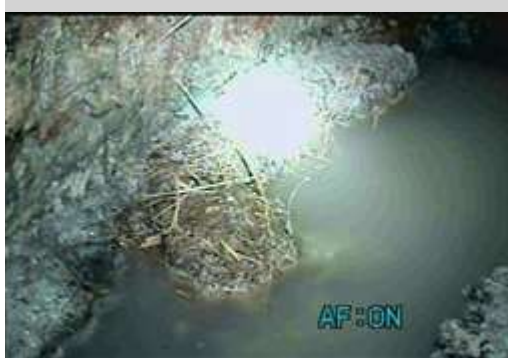
Defect 4

Condition: ☐ Sound ☐ Cracked ☐ Root Intrusion ☐ Deteriorated ☐ Leaks ☒ **Debris**

channel debris

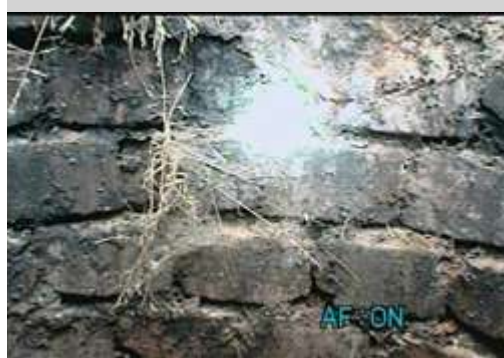
Defect 3

Condition: ☐ Sound ☐ Cracked ☒ **Root Intrusion** ☐ Loose Brick ☒ **Deteriorated**

Corbel deteriorated, frame adj

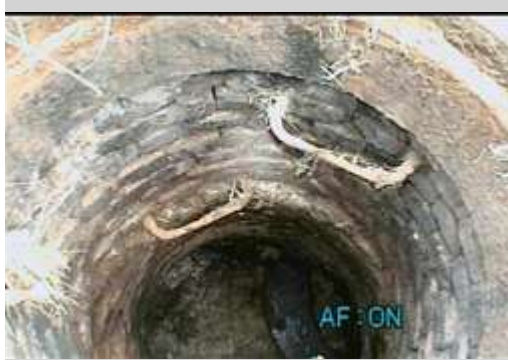
Defect 1

Count: **6** Missing: **0** ☒ **Corroded**

steps

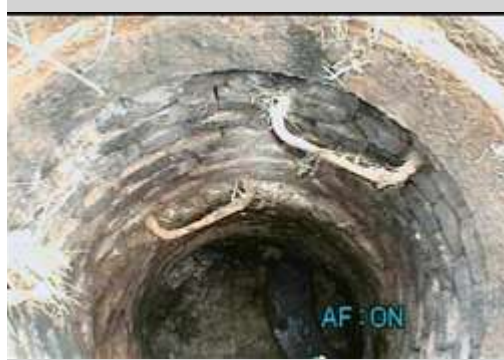
Defect 5

Condition: ☐ Sound ☐ Cracked ☒ **Root Intrusion** ☐ Loose Brick ☐ Deteriorated

Roots in Corbel and Barrel

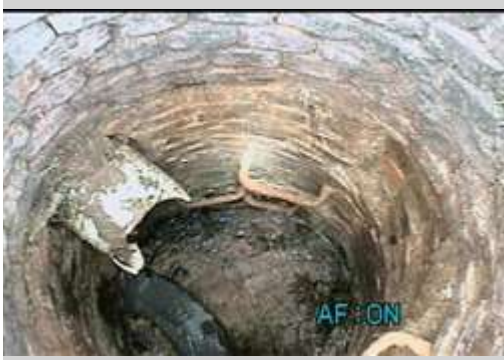
### Defect 2

☒ **Evidence Of Surcharge** Depth: **12** (ft.) ☐ Active Surcharge Present

evidence of surcharge

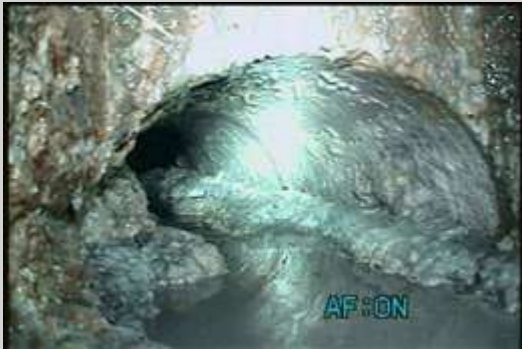
12 O'Clock Outflow

Deposits: ☐ None ☐ Mud ☒ Sludge ☐ Debris ☐ Grease

Silt Depth: 4 (in.) Deposits Extent: Medium

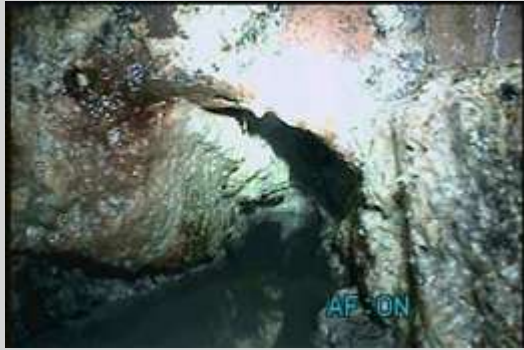
9 O'Clock Inflow

Deposits: ☐ None ☐ Mud ☒ **Sludge** ☐ Debris ☐ Grease

Silt Depth: **8** (in.) Deposits Extent: **Heavy**
